NON-DESTRUCTIVE AND NON-CONTACT EVALUATION OF ALUMINUM/ FOAM SANDWICH ELEMENTS USING LASER SHEAROGRAPHY

**Carlos Galleguillos¹, Pedro Ruiz², Emilio García², David Jiménez², Pedro Arroyo²,
Fernando Lasagni¹**

²Materials, Processes & Metrology, Airbus Defense & Space, Tablada Plant;
Seville, Spain.

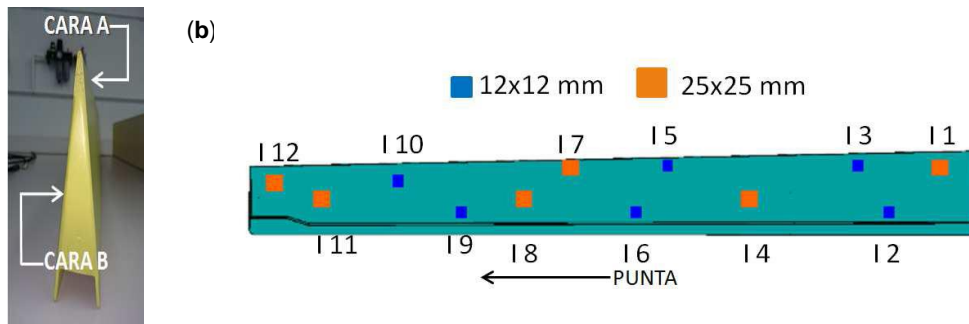
Figure 1. (a) Inspected element profile and (b) component part map indicating insertion sites.

The inspections were carried out in a sandwich type demonstrator element, manufactured with an aluminum alloy Alclad 2024 and a ROHACELL® core. Inside the element 12 artificial defects simulated with 12x12 and 25x25 mm of TEFLON® inserted into the interface joint between the laminate and core. Figure 1 features both a view of the inspected element, as well as the map of the artificial defects introduced.

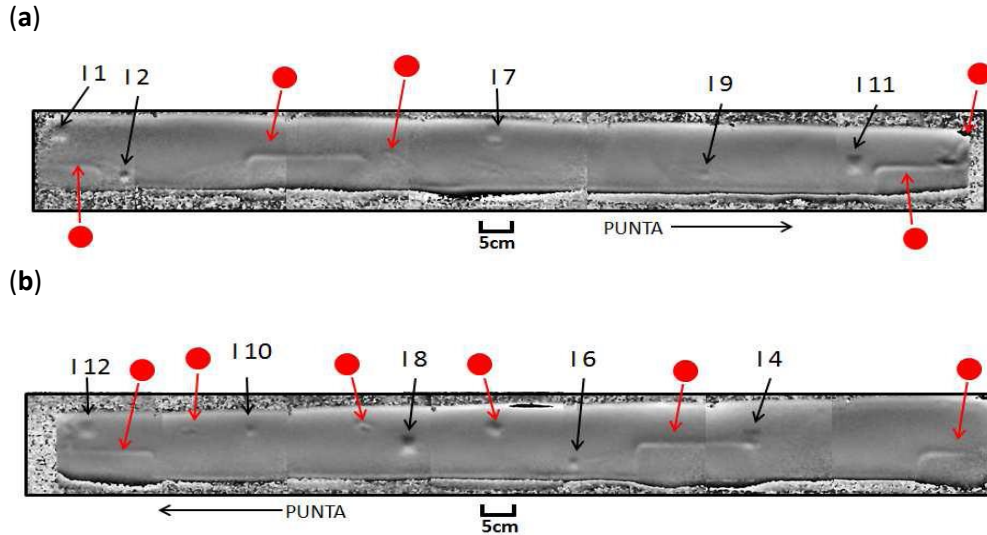
Figure 3. Inspection results obtained by laser shearography for (a) Face A and (b) Face B.

Figure 3 provides an overview of the results obtained from inspecting the element by using laser shearography. It is remarkable how this technique is capable of detecting the greater part of the Teflon inserted (I1-I12) and also locating in the item other anomalies.

The inspection results yield a very high rate of detection accuracy by allowing for visualization of 10 out of the 12 simulated insertions. It is felt that the 2 defects that remained undetectable by the technique may have experienced shifting while the element was being manufactured. In addition, 11 other anomalies are detected, which presumably are structural in nature and from lack of adhesion between the laminate and the core. There would have to be a subsequent study to determine if these 11 anomalies may be isolated by using conventional non-destructive testing methods prior to the inspection by means of laser shearography or by destructive methods such as dissection of the element in order to determine the type of discontinuity that gave rise to the anomaly. Also it would be advisable to look into the reason why 2 of the 12 insertions remain undetectable.
