Usage of digital image correlation in assessment of behavior of block element pavement structure

M Grygierek¹ B Grzesik¹ P Rokitowski¹ T Rusin²

¹The Silesian University of Technology, Gliwice, Poland ² Dantec Dynamics GmbH, Ulm, Germany

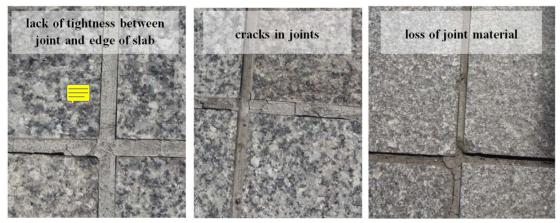
Figure 4. Stages of joint's deterioration.

Characteristic feature of granite slabs pavement were damages of joints between slabs. Several types of this damages could be distinguished such as lack of tightness between joint and edge of slab, cracks in joints and loss of joint material (Figure 4). Dilatation joints were exceptional, because of the elastic material used to fill joint which was not damaged (Figure 5).

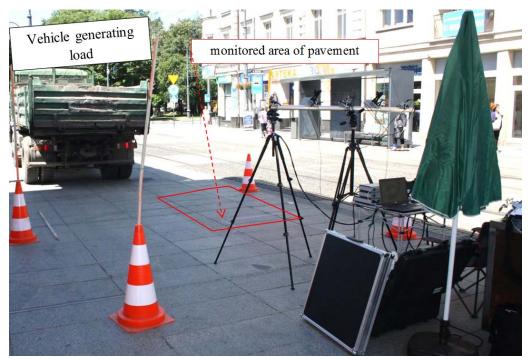
Figure 7. Test stand during DIC deflection measurements of block element pavement structure.

Displacements of pavement structure under a load generated by heavy truck were measured using Digital Image Correlation system. Test stand was shown in the Figure 7. The test stand consisted of three cameras located linearly on a stiff aluminum profile with length of 2.0 m. Monochromatic cameras with 5 Mpx resolution and lenses with focal length equal to 12 mm were used. The central camera was located around 3678.32 ± 0.10 cm from the central point in the field of view (FOV). For granite slabs there were no necessity to mark the surface with stochastic markers, because granite has a natural grained structure with different gray scale tones (Figure 8). Analysis of deformation was executed using a mesh with more than 13 000 elements with size of single facet equal to 17 px. In the principal point (central point of the FOV) resolution is equal to 1Px/1mm, but resolution of DIC measurement is different in different areas of the FOV. In the areas covered by three cameras resolution is better than in areas covered just by two cameras. Optical axis of cameras was inclined at 45 degrees to the measured surface, what means that in the area closer to the cameras resolution was better than for area further away from the cameras. Resolution in horizontal and vertical direction in Px/mm is the same. Calibration was executed using square calibration board with a 750 mm long edge.
