A Comparison of Laser Shearography and C-Scan for Assessing a Glass/Epoxy Laminate Impact Damage

Martin Kadlec · Roman Růžek

Keywords Polymer matrix composite · Impact damage · Laser shearography · C-scan · Aerospace vehicles

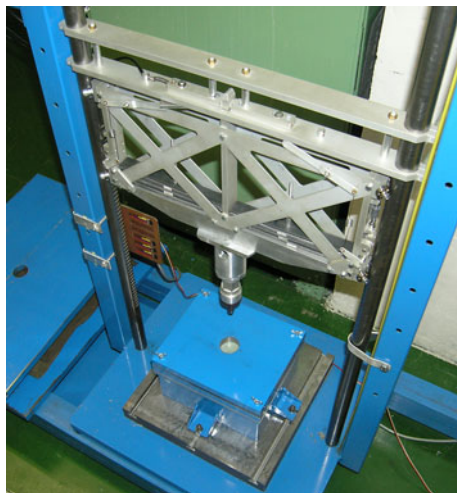
Fig. 1 Impact machine set-up with a clamped specimen between 2 boards

This configuration is considered a large-mass dynamic impact loading. The velocity detector was adjusted to measure the velocity just before the nose struck the specimen. Multiple impacts were prevented. The laminates were clamped vertically by a plate with a hole. Figure 1 shows the experimental setup for the impact test.

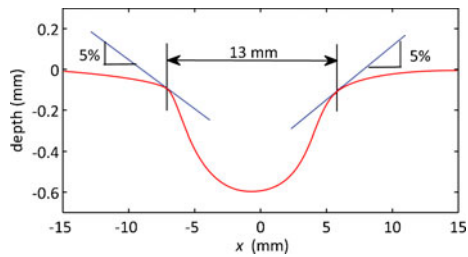
Fig. 2 Evaluation of an indentation diameter from a dent profile curve

Residual impressions can barely be detected in practice by a classic visual inspection, especially when the damage can be classified as BVID. It is generally assumed that indentations with depths less than 1 mm belong to this group. The surfaces of the indentations were scanned with an indicator gauge with a resolution of 0.01 mm. These contact measurements of the *z* axis (depth) were recorded over the line going through the middle of the dents. In addition, some specimens were measured in more detail over the whole area around the dent with a grid size of approximately 1 mm. The dent profile size was evaluated by applying 5% gradient lines to the edges of the dent. An indentation diameter was determined from the distance of the two intersection points defined by the supporting lines and the dent profile (Fig. 2).

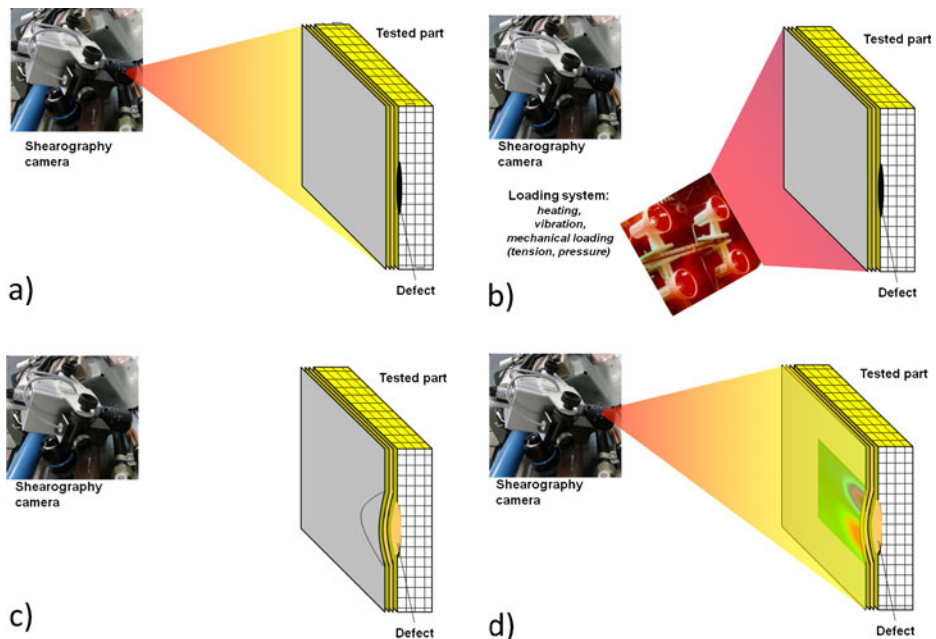
Fig. 3 Principle of shearography: **a** reference image is taken, **b** tested part is loaded, **c** unloading induces deformations and **d** images are superposed with the reference image

two images is called a shearogram; it is an interferogram of an object wave with the sheared object wave as a reference wave. Figure 3 explains the measuring procedure.

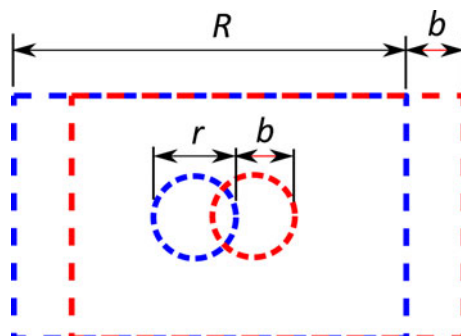
Fig. 4 Recalculation of a flaw indication size ($r + b$) by subtracting shear b

The recorded interferograms of any of the recorded states can be compared and doing so produces fringe patterns. It turned out to be essential for maintaining the low noise level to use the last interferogram from the measurement series as the reference image. The pattern can be recalculated into a deformation gradient. Around a thermally loaded flaw, this gradient is indicated by a typical “butterfly pattern”. The shear base distance should be subtracted from the indicated flaw size measured on the butterfly pattern (Fig. 4).

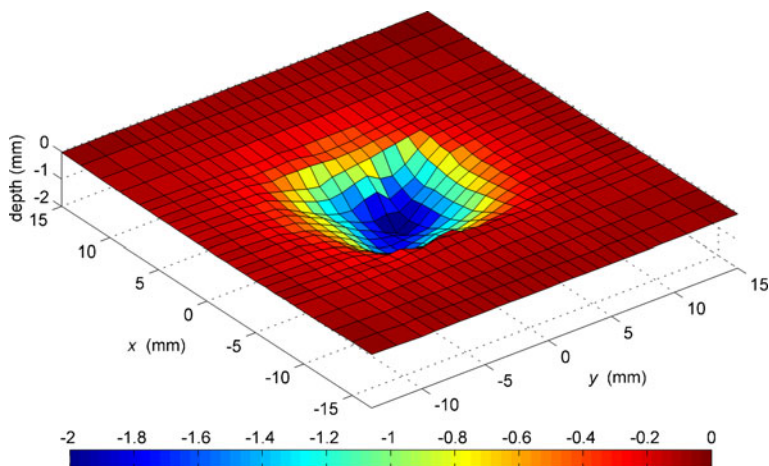
Fig. 5 Residual impression of a 35 J dent

The residual impressions after impact were measured. Figure 5 shows the typical surface shape of the 35 J dent, which was approximately 2 mm deep. The rest of the dents were measured in a line parallel to one of the specimen's edges. The dent profiles for different impact energies are demonstrated in Fig. 6. The diameter of the indentation area is determined on the basis of these profiles with the 5% gradient edge. The indentation depth was measured as the minimum value of a dent profile. Dent depths show a general rising trend with increasing of peak energy. The depth values vary from 3.4 mm for the 40 J dent to less than 0.1 mm for 5 J dents. The 35 and 40 J dents were substantially deeper than the rest of the dents formed with lower damage energies. This occurred because the laminate was 3.5 mm in thickness, and there was not enough supporting material for the damage to be absorbed. These values are summarised in the first part of Table 1. The deformation profiles also include the diameters of the indentation areas measured using the 5% gradient supporting lines. The maximum damage diameters vary from 6 to 19 mm as a function of the impact energy. These values are shown in the same table.

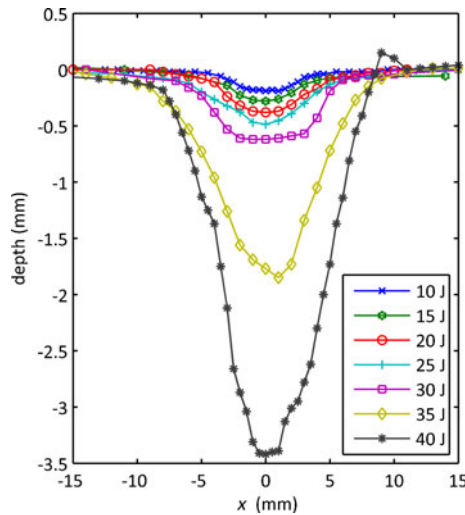
Fig. 6 Dent profiles of laminates impacted by various energies. The laminate was 3.5 mm thick

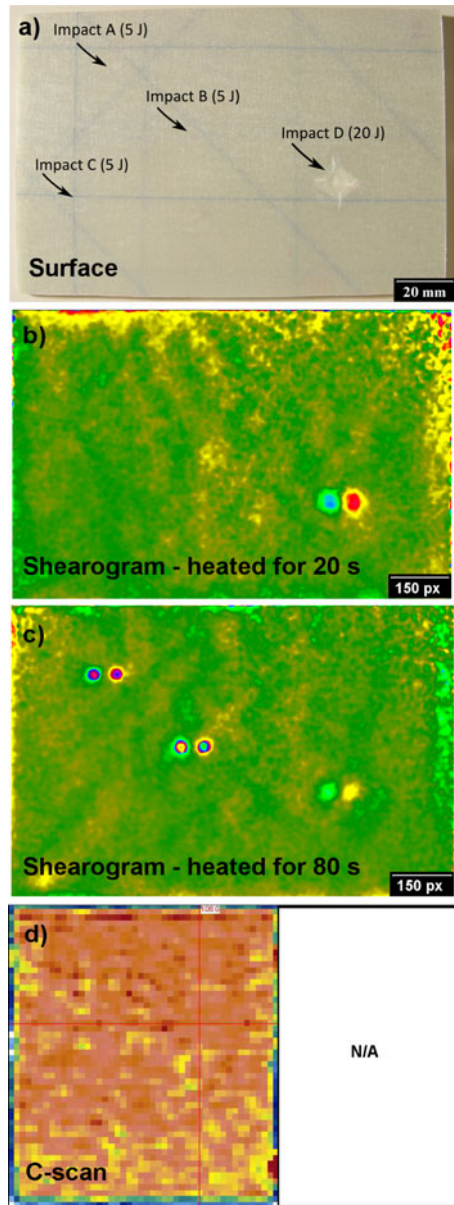
Fig. 7 **a** Impacted specimen surface with 4 dents where 5 J damage is not visible, **b** phase image of this specimen heated for 20 s, **c** another phase image of this specimen heated for 80 s where even some 0.1 mm deep dents can be detected, **d** ultrasonic C-scan of the corresponding area in amplitude visualisation

The shearography evaluation of the indentations can be influenced by heating time, which causes different rates of deformation. Figure 7a presents a specimen damaged by three 5 J impacts and one 20 J impact. Additional interferograms under different loading

conditions were obtained for this specimen. The first measurement was performed after 20 s of heating (Fig. 7b). In this case, only the 20 J impact was indicated. Then, 40 s of heating was performed with the same result. Finally, 80 s of heating was applied to increase the deformation gradient even more. This intensive loading indicated two of the three 5 J dents, which were less than 0.1 mm deep (Fig. 7c). This image was recorded several seconds after heating when the temperature decrease was sufficiently fast. However, the measurement of the intensive deformation gradient reduced the visibility of the 20 J damage pattern.

Some of the specimens were measured with an ultrasonic C-scan, which provides a topological image of the laminate. The discussed four-dent specimen was used. Because other kinds of specimen evaluations were also done, only the left part of the specimen with 5 J dents was measured (Fig. 7d). The C-scan did not detect any of these 5 J indentations for the used parameters.

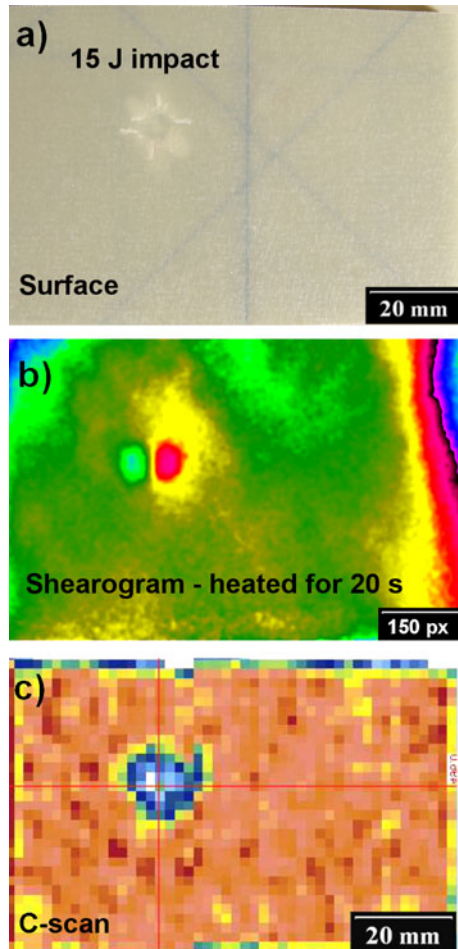
Fig. 8 **a** Impacted specimen surface with a 15 J dent, **b** phase image of this specimen heated for 20 s, **c** ultrasonic C-scan of the corresponding area in amplitude visualisation

The second examined specimen was damaged by a 15 J impact (Fig. 8a). The phase image of the shearogram indicated a dent with the typical pattern (Fig. 8b). An ultrasonic C-scan provided a topological image that revealed the delamination of the 15 J damage (Fig. 8c).

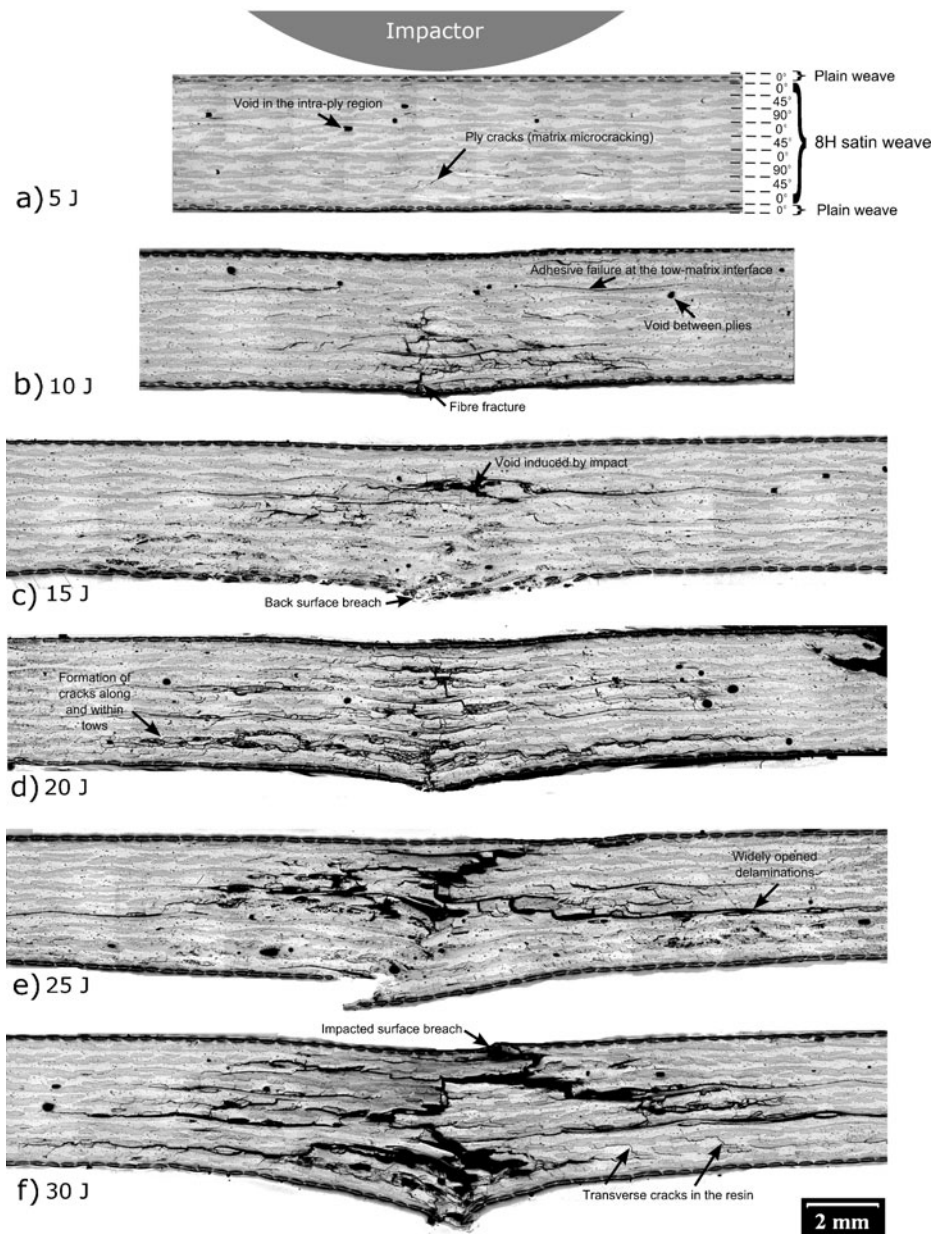
Fig. 9 Cross-sectional photographs of the woven glass fabric laminate in a bright field illumination. Observed damage for various impact energies is described

A metallographic examination in a bright field illumination was performed on cross-sections of the dents. The maximum range of the damaged area on the cuts was measured and is noted in Table 1 as the inner damage. Figure 9a shows the cross section of a 5 J impact location with minor ply cracks (matrix microcracking) in $\pm 45^\circ$ tows. A void due to entrapped air is shown in the inter-ply region. Both the specimen surfaces are coherent. Figure 9b shows the 10 J impact site with multiple ply cracks and delaminations on the non-impacted (back) side of the laminate. Most of the observed delaminations can be characterised as adhesive failure at the fibre (tow)-matrix interface. Fibre fracture is visible in some 0° plies. The impacted (front) side for up to 1/3 of the specimen depth is undamaged in the centre. Only delaminations along 0° tows are apparent further from the centre. Figure 9c presents the 15 J impact location. The damage character is similar to the 10 J impact, but the area has a higher extent of delaminations, and the undamaged area below the indentation is reduced. A void induced by impact damage is apparent. The back surface of the laminate is broken which is the case for all of the specimens impacted by energies greater than 15 J. Figure 9d shows the 20 J impact site. The damage consists of delaminations and microcracks along and within tows that spread through the whole thickness of the specimen. The cracks are connected to the extended formation. Fibre fracture along the vertical axis is apparent. The indented surface is still coherent. Figure 9e displays the 25 J impact location. Delaminations are widely opened and extend to larger distances from the indentation area. Fibre fracture occurs throughout the thickness. The front surface is not broken through. Figure 9f shows the 30 J impact in which both the front and back surfaces are breached. Transverse cracks in the resin-rich areas connect horizontal cracks along adjacent plies.

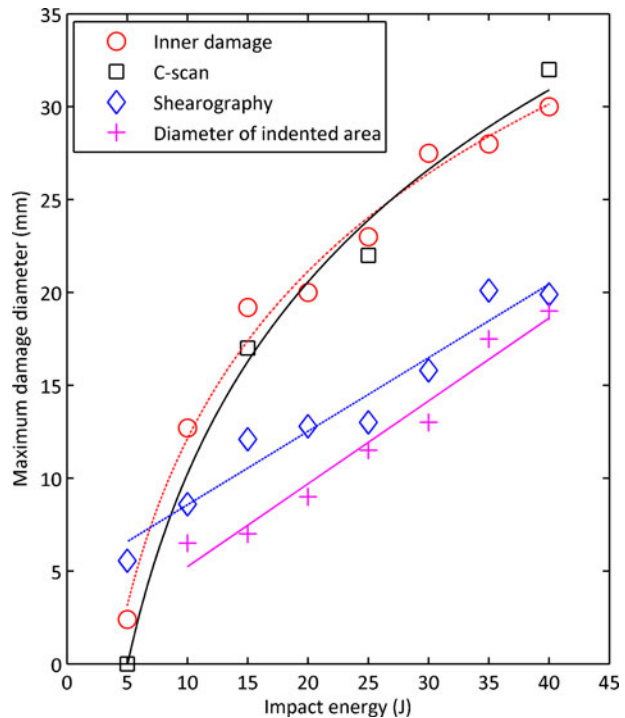
Fig. 10 Comparison of the maximum diameter of the inner damage, the indented surface area and the detected flaw indications with two NDT techniques—the ultrasonic C-scan and laser shearography

Figure 10 summarises the results of the damage indications compared with the real damage state and the indentation area diameter. Circular points correspond to the inner metallographic results, dagger-shaped points correspond to the indentation area diameter and the remaining points represent the C-Scan and shearography results. The inner damage diameter plotted against impact energy can be fit by a logarithmic curve. The same can be done for the C-Scan values. The curves have very similar parameters. It can be stated that the ultrasonic C-Scan method evaluated the real damage effectively. The shearography indications and the diameter of the indented surface can be fit by a linear relation. It can be concluded that shearography is the most suitable method to detect surface residual indentations. Moreover, the measurements are very rapid, and the technique is capable of detecting even the smallest damage from a 5 J impact.
